**BEAUFORT COUNTY
HISTORIC SITES SURVEY - 1997**

INTENSIVE LEVEL BUILDING INVENTORY FORM

Historic name(s): Union Baptist Church Map Ref.: PR 07 - BFT Tax Number: R110 011 000 0144 0000
Common name(s): The Beaufort Lodge City Block Ref.: _____ Island: Port Royal Is.
Address/location: 1708 Old Shell Rd. City/Vicinity of (vic.) Port Royal
Date: 1900 ca. Alteration date: 1970 ca.
Ownership: 1. private 2. city 3. county 4. state 5. federal 6. unknown
Category: 1. building 2. site 3. structure 4. object
Historic use(s): church Current uses: church

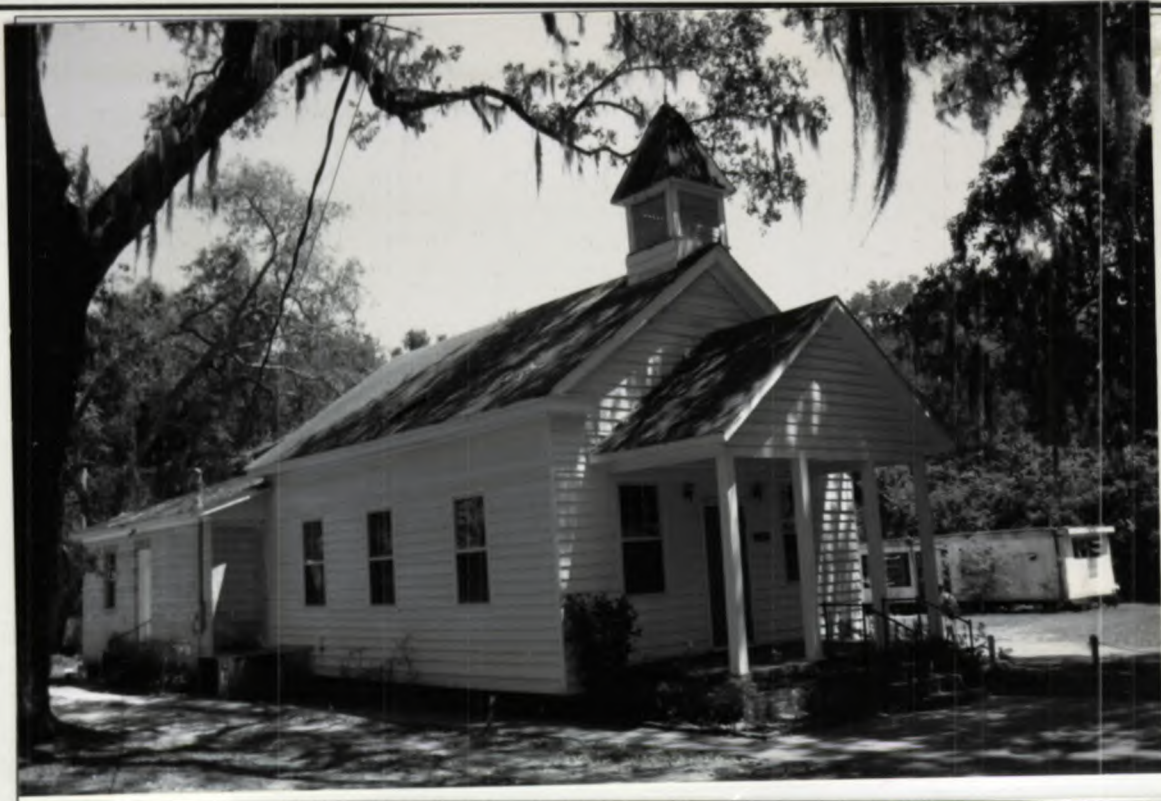
Photograph:

Roll # Neg. View of:
S-01 14 W facade & N elev., fac. SE

Alterations: Alteration date: 1970 ca. Integrity: good Condition: good
Rear addition, replacement front door, porch posts, brick infill at foundation

Description: 1 story rectangular 3 x 3 bay frame church w/front-facing gable composition shingle roof. 3x3 bay block addition at rear. Small square belltower at front of roof ridge w/hipped roof and rectangular louvered vents. Boxed cornice w/returns. Central entrance at facade flanked by single 6/6 double hung sash widows. 6/6 windows at each bay of side elevations.
