**BEAUFORT COUNTY
HISTORIC SITES SURVEY - 1997**

INTENSIVE LEVEL BUILDING INVENTORY FORM

Historic name(s): Lee, Peter, Farmhouse Map Ref.: BFT 06 Tax Number: R100 029 000 0153 0000
Common name(s): Pulaski House City Block Ref.: _____ Island: Port Royal Is.
Address/location: 19 Icehouse Rd. City/Vicinity of (vic.): Beaufort vic.
Date: 1890 ca. Alteration date: 1980 ca.
Ownership: 1. private 2. city 3. county 4. state 5. federal 6. unknown
Category: 1. building 2. site 3. structure 4. object
Historic use(s): single dwelling Current uses: abandoned

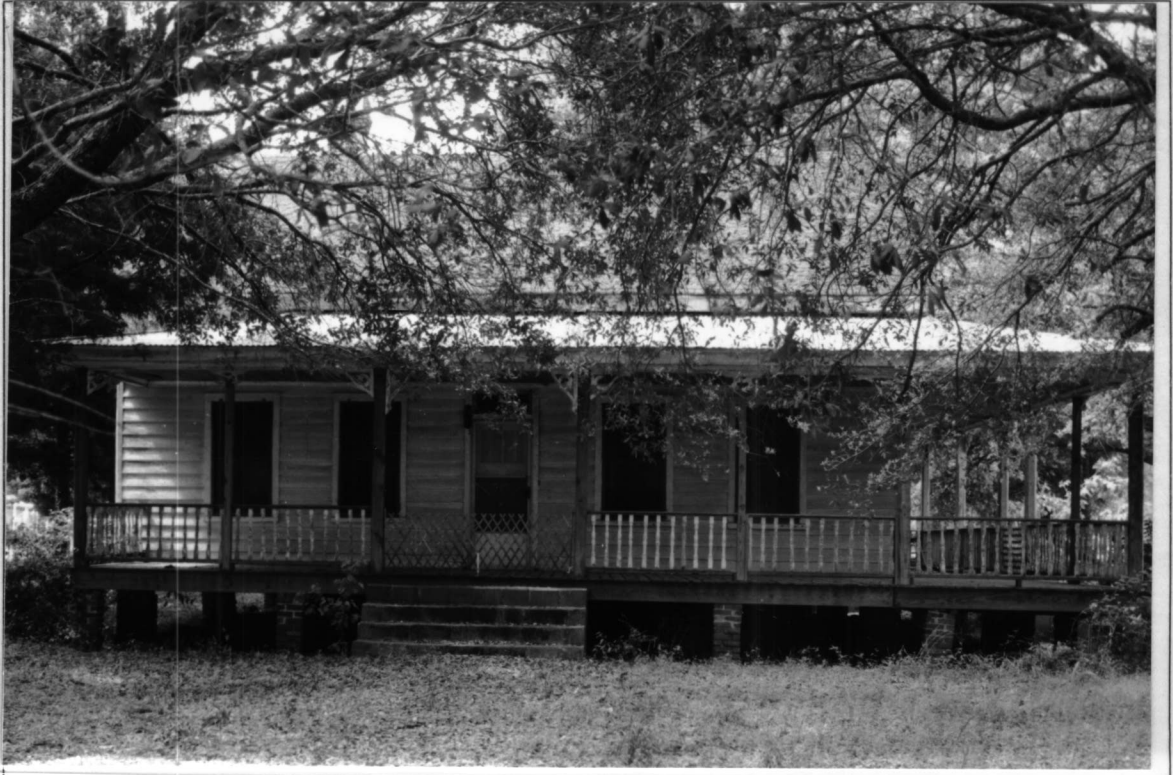
Photograph:

Roll # Neg. View of:
B-03 18 E facade, fac. W
B-03 17 N facade. fac. S
B-03 16 Dupe 16
B-03 19 S & W elevs., fac. NE

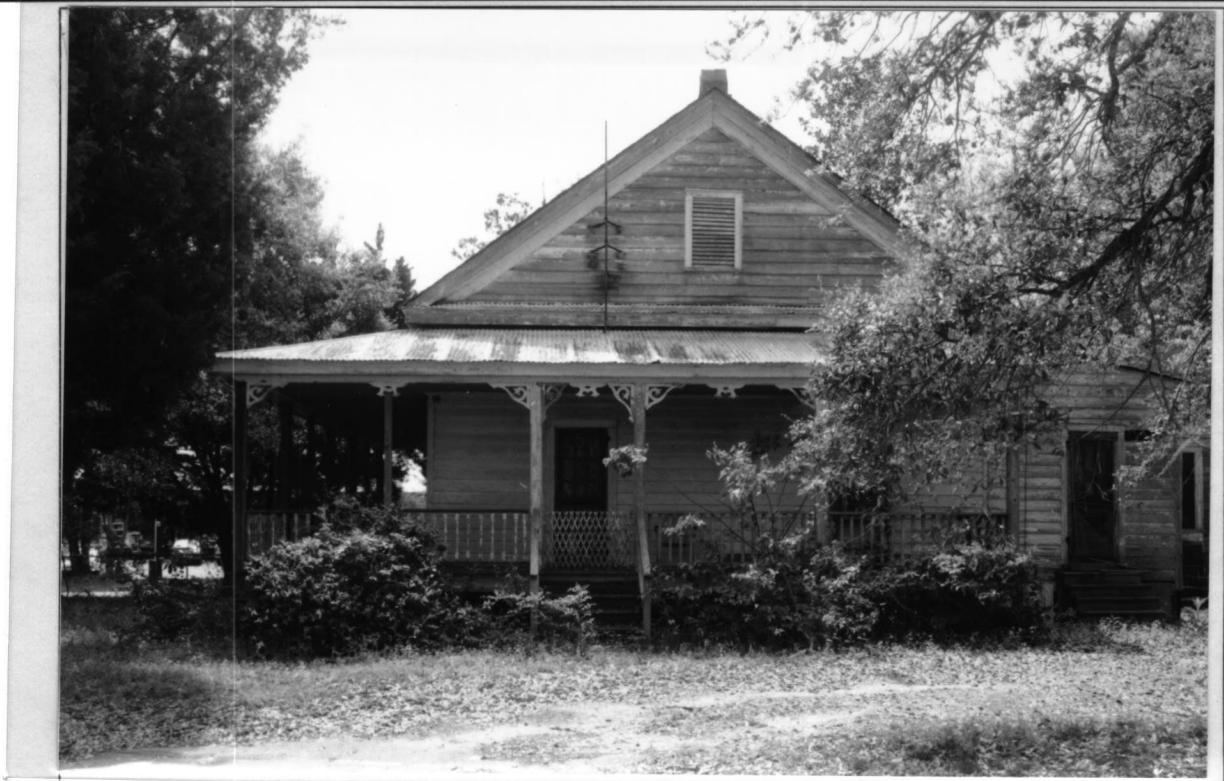
Photograph:

Roll # Neg. View of:
B-03 18 E facade, fac. W
B-03 17 N facade. fac. S
B-03 16 Dupe 16
B-03 19 S & W elevs., fac. NE

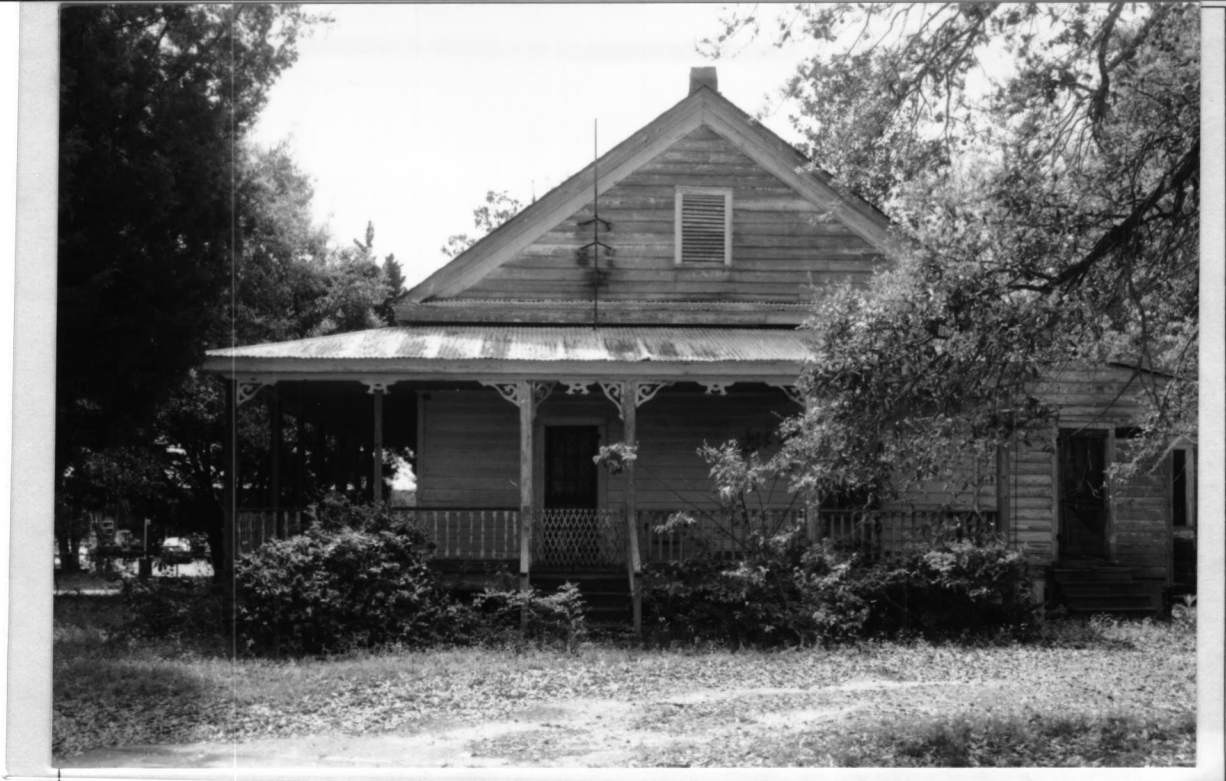
Photograph:

Roll #	Neg.	View of:
B-03	18	E facade, fac. W
B-03	17	N facade. fac. S
B-03	16	Dupe 16
B-03	19	S & W elevs., fac. NE

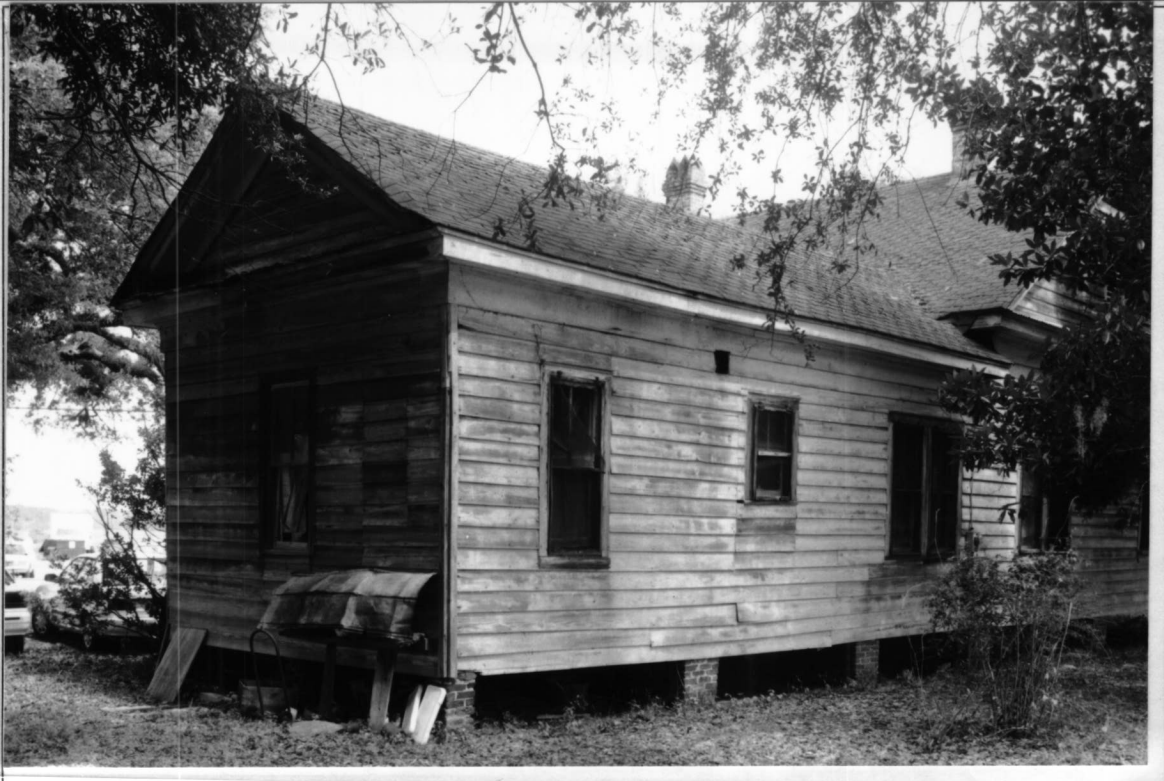
Photograph:

Roll #	Neg.	View of:
B-03	18	E facade, fac. W
B-03	17	N facade. fac. S
B-03	16	Dupe 16
B-03	19	S & W elevs., fac. NE

Alterations: Alteration date: 1980 ca. Integrity: good Condition: good
some porch elements replaced; kitchen addition constructed circa 1945

Description: 5 x 2 bay rectangular block w/cross gable rear wing at left, small shed rear addition at right; pedimented gable ends w/rectangular louvered vents; boxed cornice; dawn brackets at porch
